CUSTOMER INFORMATION BULLETIN

We have identified a potential problem with a small proportion of **R57003-EZI Rocket® EZI Plug Fetal Scalp Electrodes** where the two halves of the finger grip have separated and in isolated cases become detached.

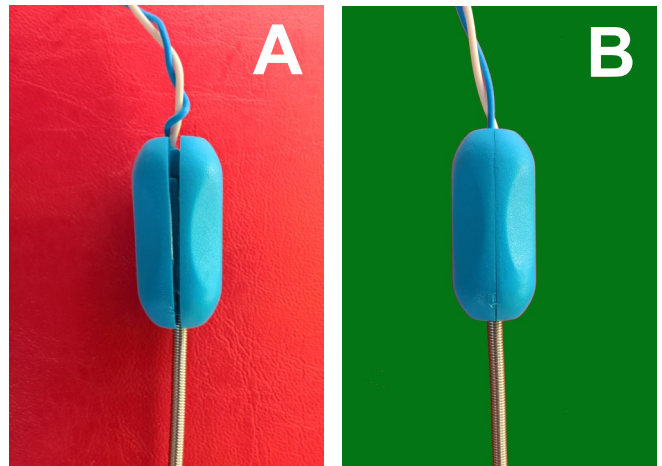
The defect is readily identified as a distinct separation of the shell halves. As a precautionary measure, the electrode should be examined before application and any items that show evidence of separation as in **Image A** should be returned to Rocket Medical for credit or replacement

Items where the shell halves do *not* show evidence of separation (**Image B**) may continue to be used.

This issue has been caused by a uncharacteristic failure of the internal bonding method following EtO sterilisation. This has been corrected for future manufacture.

FAULTY - REJECT/RETURN

OK- READY FOR USE
