CUSTOMER INFORMATION BULLETIN

We have identified a potential problem with a small proportion of **R57003-EZI Rocket® EZI Plug Fetal Scalp Electrodes** where the two halves of the finger grip have separated and in isolated cases become detached.

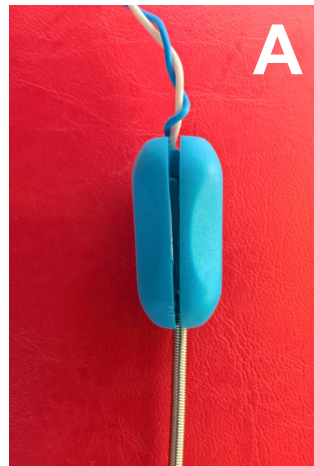
The defect is readily identified as a distinct separation of the shell halves. As a precautionary measure, the electrode should be examined before application and any items that show evidence of separation as in **Image A** should be returned to Rocket Medical for credit or replacement

This issue has been caused by a uncharacteristic failure of the internal bonding method following EtO sterilisation. This has been corrected for future manufacture.

FAULTY - REJECT/RETURN

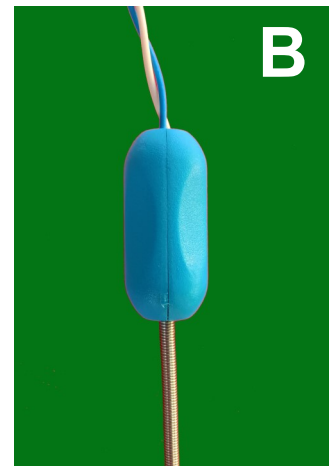
Items where the shell halves do *not* show evidence of separation (**Image B**) may continue to be used.

OK- READY FOR USE
